Nevada Irrigation District Centennial Reservoir Project Preliminary Geotechnical Investigation Phase II Report – Final

Subject: Centennial Reservoir Project, Preliminary Geotechnical Investigation Phase II Report – Final

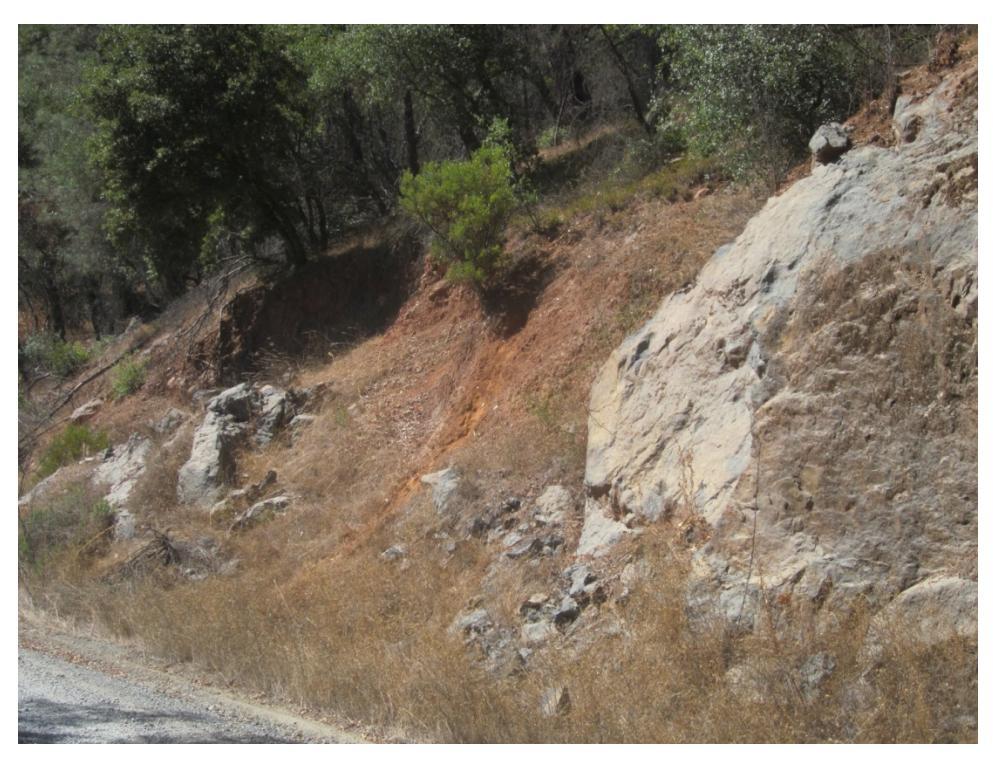
Photograph 1. Typical section of residual soil observed within a road cut southwest of the CRP site

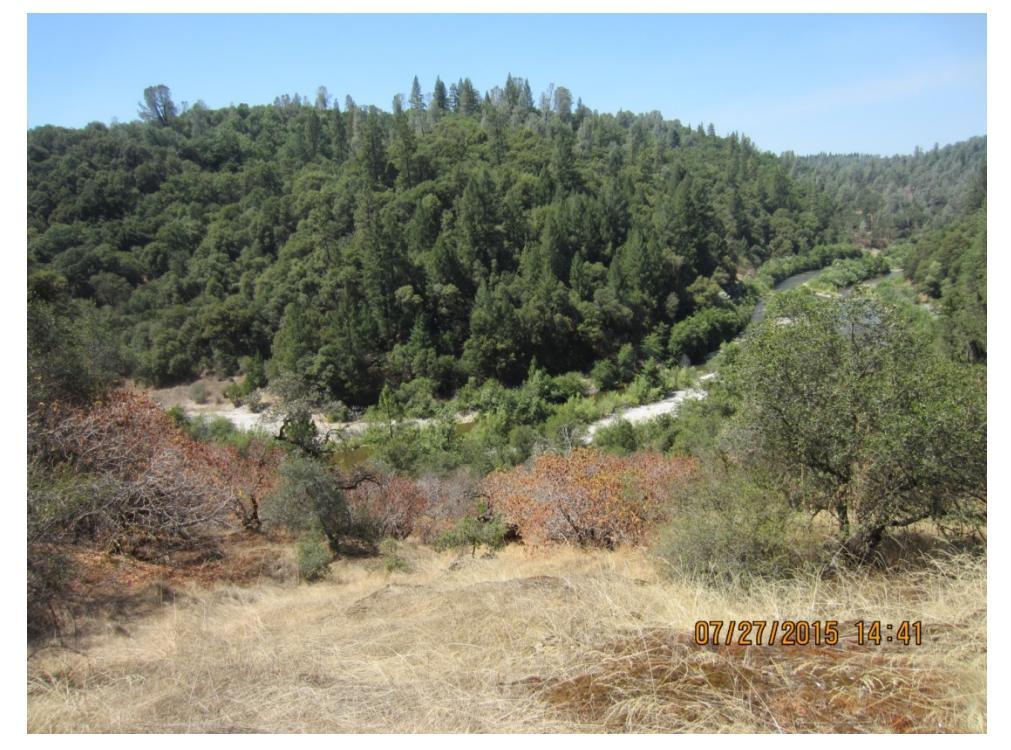
Alluvial deposits are present in the CRP dam site area between the abutment slopes and across the Bear River channel, which has a width of between 150 and 300 feet. The deposits consist of sandy gravel to gravelly sand and locally contain cobbles and boulders. The gravels and larger clasts include granite, quartzite, and vein quartz from rock which is not present on the project site. These materials were derived from higher up to the east in the Bear River drainage basin. Though none was observed during the geologic mapping effort, the alluvial deposits may also contain chert based on the mapping performed by Tuminas (1983). Alluvium is present variably within the river channel, which also contains extensive rock outcrops. The approximate limits of the alluvium in the site area are shown on Figure 4-1. Bedrock outcrops in the active river channel are also shown in Figure 4-1. Photographs 2 and 3 illustrate the Bear River alluvial deposits.

Photograph 2. Northwest facing view of the Bear River from the southeast end of the site [Illustrates distribution of alluvial deposits within the active channel (Left: point bar; Right: mid-channel bar)].

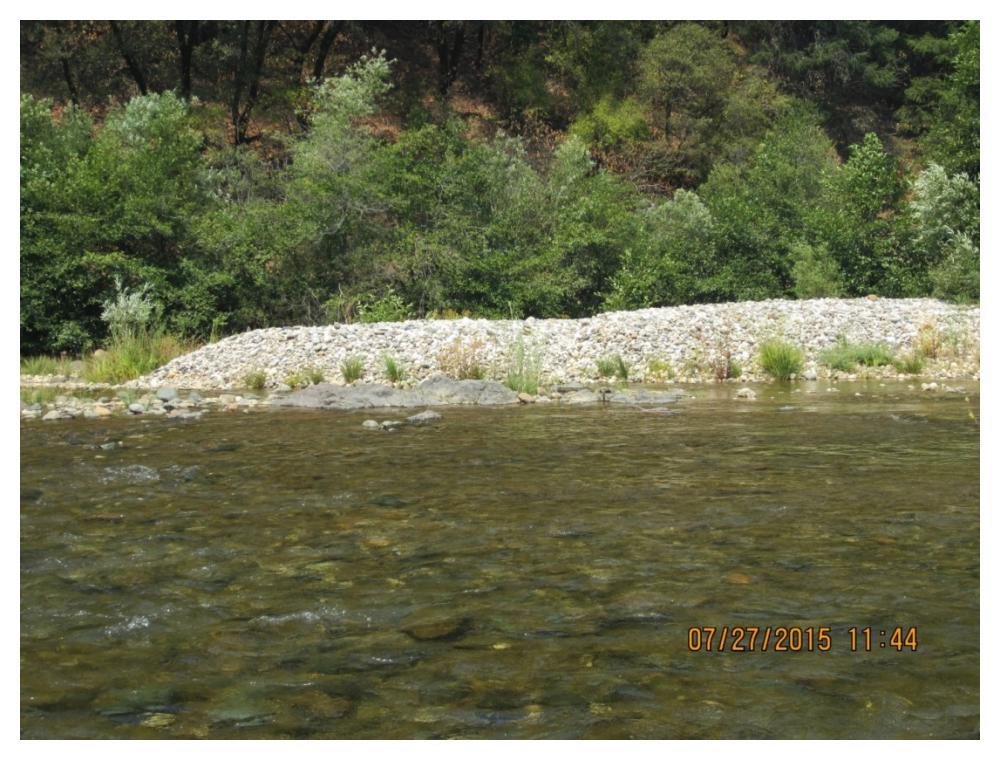
Photograph 3. West facing view of outcropping bedrock and mid-channel bar deposits within the Bear River at Axis 6

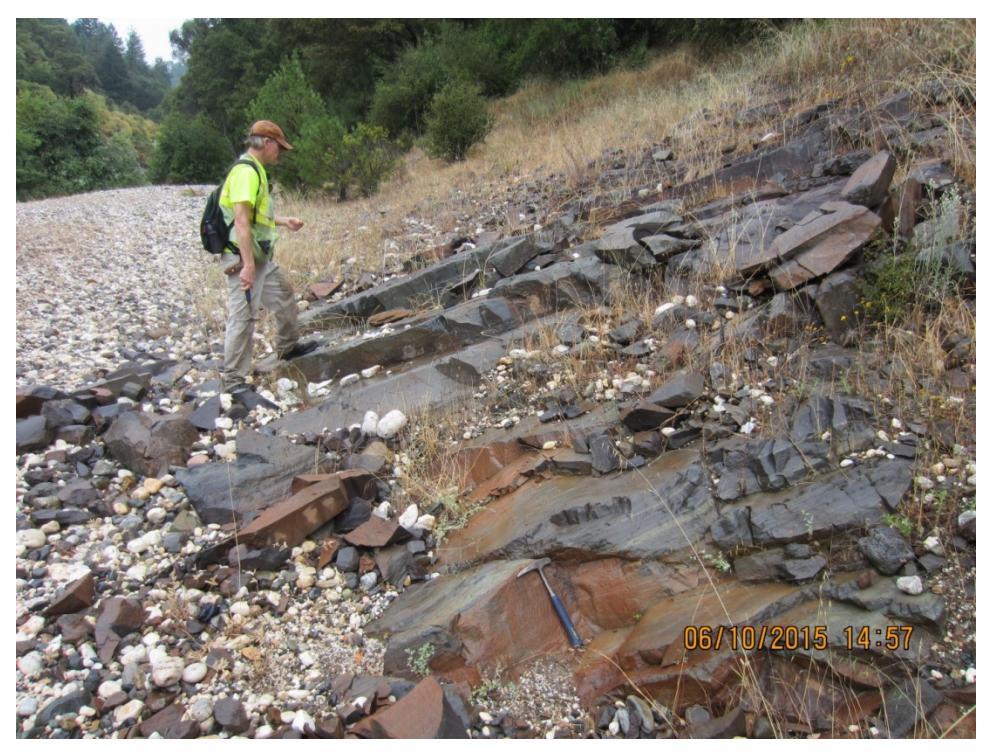
Photograph 4. West facing view of bedding in outcropping bedrock (massive basalt) at the toe of slope along north bank of Bear River, near Axis 4

[Well rounded cobble and gravel sized point bar deposits are also visible (Left).]

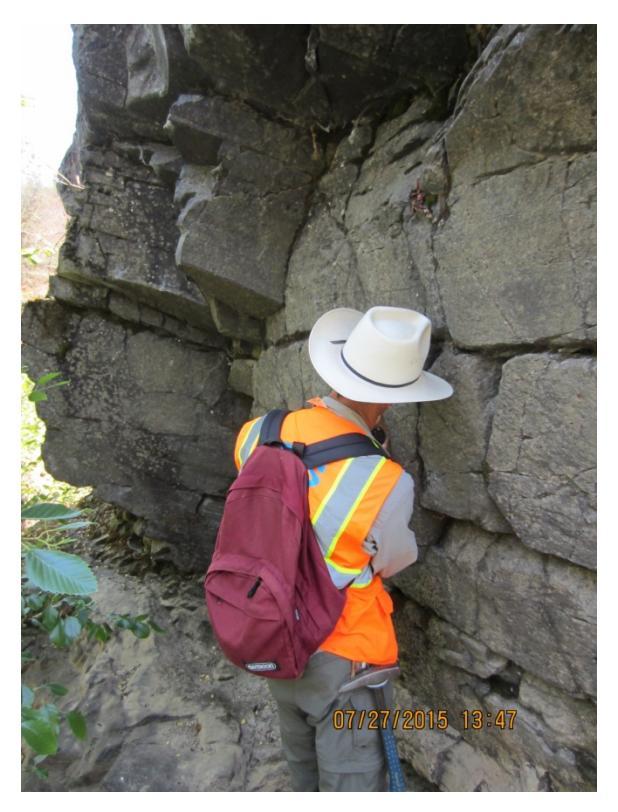
Photograph 5. East facing view of typical discontinuities in outcropping bedrock (massive basalt) at the toe of slope along the south bank of Bear River, near Axis 4

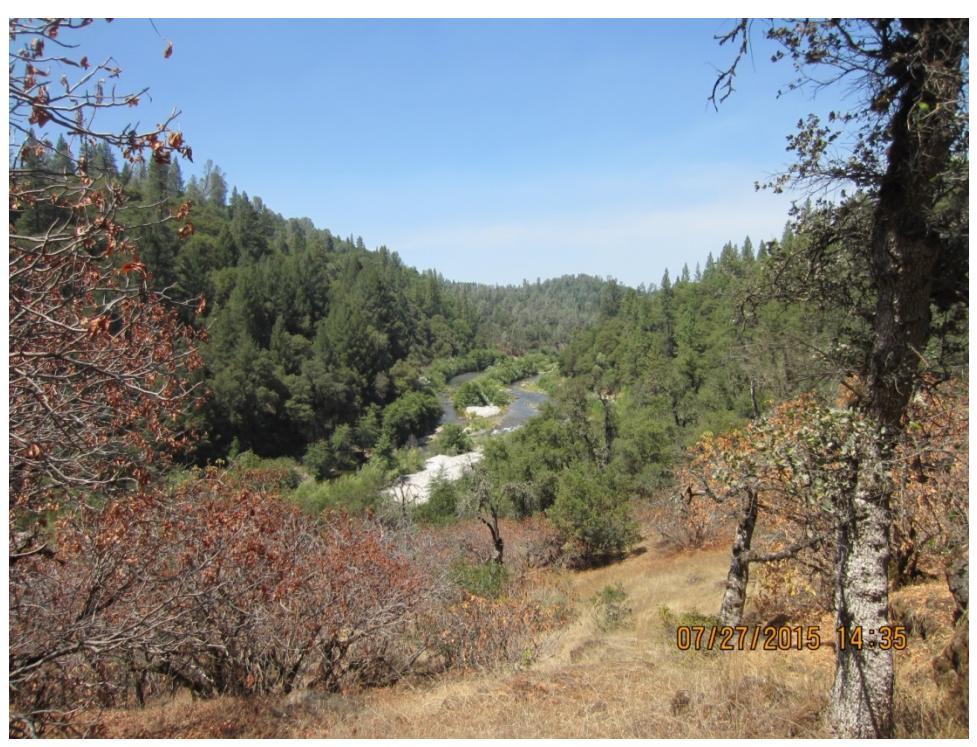
The observed outcrops on both the north and south sides of the river canyon are comprised of similar rock. The rock is massive, dense, hard, strong, black to gray, fine grained, generally unweathered to slightly weathered basalt. The outcrops display widely spaced steep joints and gently inclined volcanic flow "bedding" surfaces. Rock outcrops are present in many places along the toe of the slopes near the river and in the active river channel. Near the river many of the outcrops are present as cliffs. A tall cliff on lower half of the north bank of the river near the western edge of the site area was too steep to safely access on foot. Within the river channel many of the observed outcrops have been smoothed by fluvial erosion. Figure 4-1 shows the locations of the observed rock outcrops with recorded strike and dip information as well as the locations of observed possible landslides. Photographs 4 and 5 illustrate the bedding and joint conditions of the bedrock. Photographs 6 and 7 illustrate the general morphology of the site.

Photograph 6. North facing view the Bear River channel at Axis 6

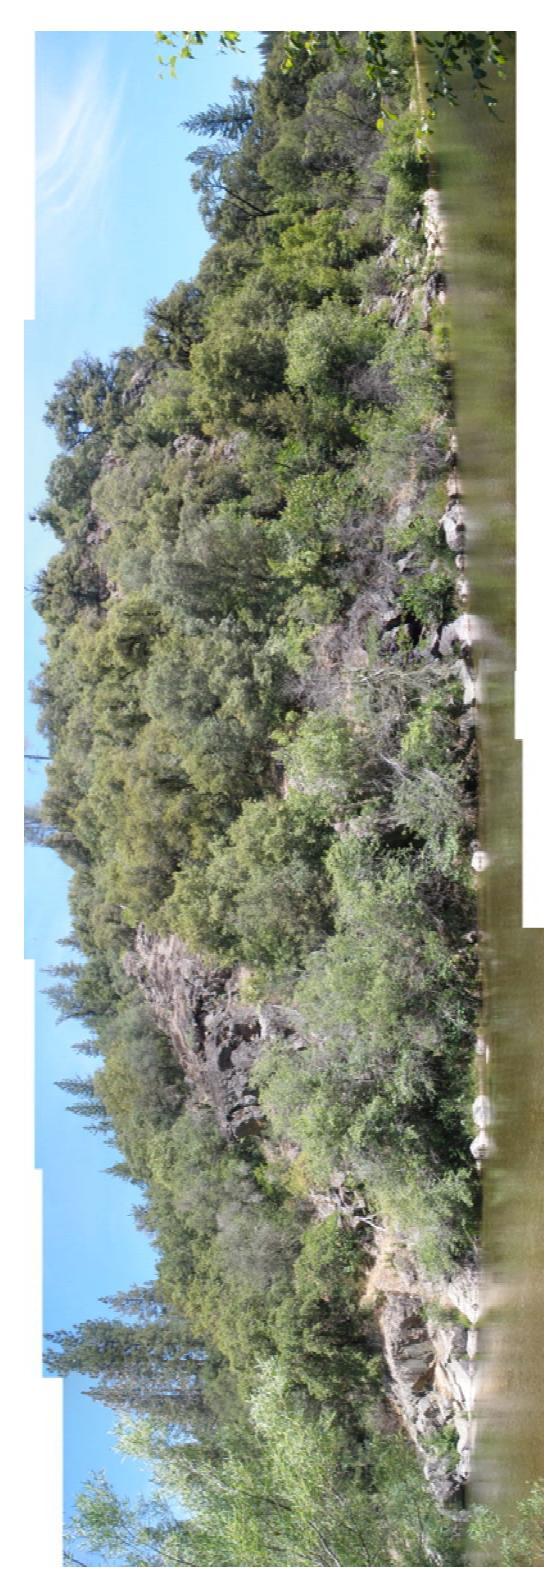
Photograph 7. North facing view of the right abutment at Axis 2 [Illustrates steep (up to sub-vertical) slopes of outcropping bedrock (massive basalt).] 5

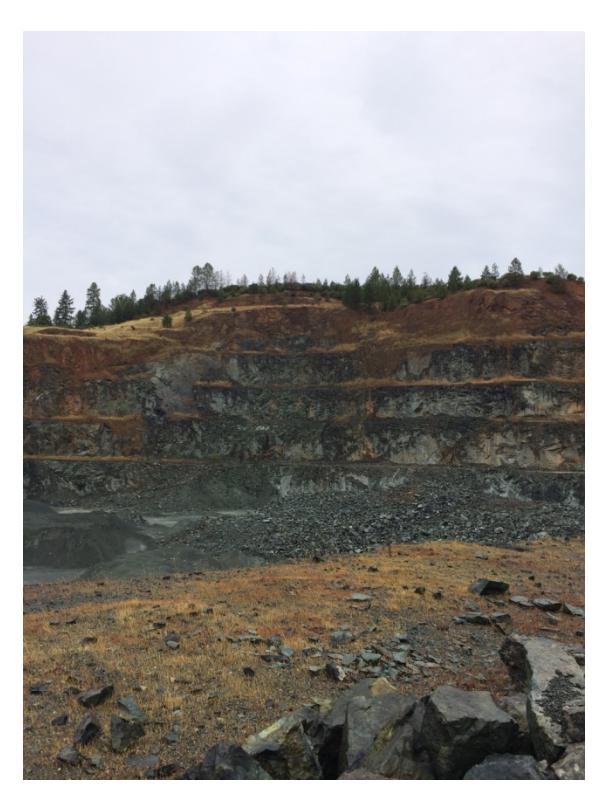
As stated in Section 3, no faults considered active by either the California Geological Survey or US Geological Survey are mapped within the CRP dam site area. During the mapping for this project, two minor inactive faults or shear zones were observed within the nearby rock quarry. Based on observations of the sheared bedrock zones, these features are about 5 to 15 feet wide in outcrop, and are both very steep to vertical. The first is oriented N55°E and the second between N10°E and N12°W. These features appear to coincide with a regional discontinuity fabric that follows local meanders of the Bear River. The second feature strikes directly toward the north-south stretch of the Bear River within the CRP dam site area. The rock observed within these features is highly fractured, sheared and discolored, but the fabric remains hard and strong. Slickensides present along shear surfaces indicate a strike slip sense of past movement. Rock surrounding the upper portion of the north-striking feature is exposed high on the north wall of the quarry as a zone of reddish brown discolored and possibly weathered rock that widens closer to the original ground surface. Photographs 8 and 9 illustrate the minor inactive fault or shear zone features observed in the quarry.

Photograph 8. North facing view of quarry shear zone in Teichert quarry [Orientation between N10°E and N12°W (arrow points to shear zone).]

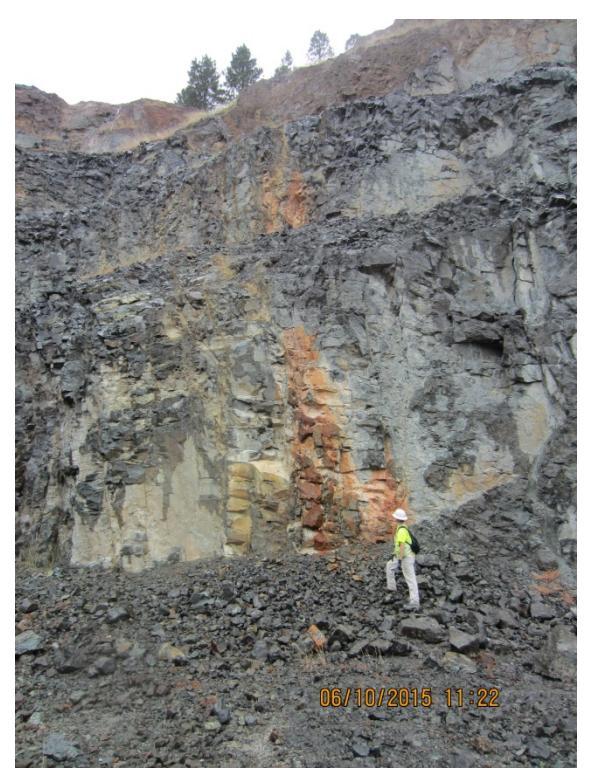
Photograph 9. North facing close-up of quarry shear zone

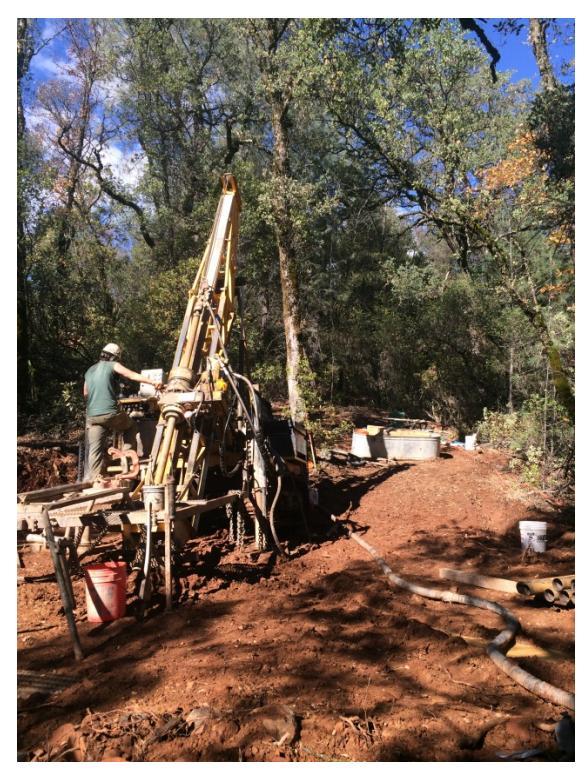
Photograph 10. Drilling Boring CB-3 (Axis 2, right abutment)

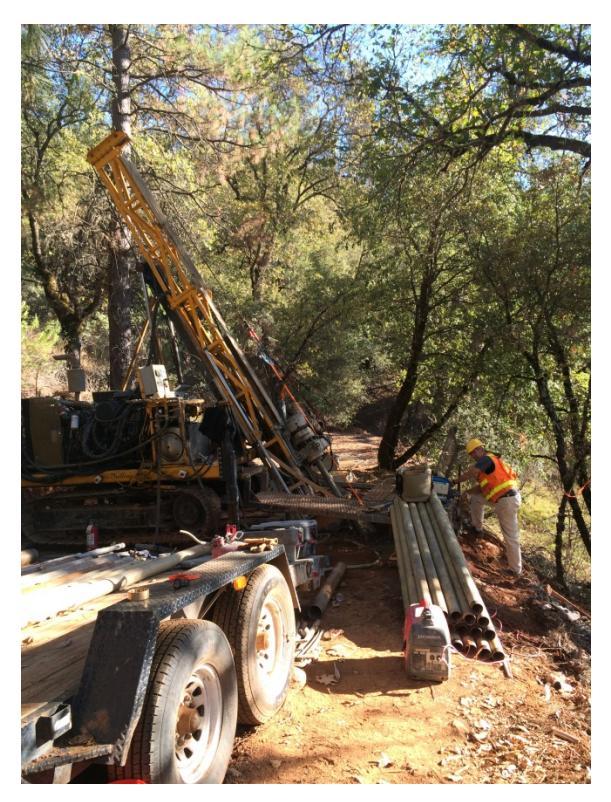
Photograph 11. Drill rig with televiewer logging at Boring CB-6 (Axis 6, left abutment)
