Submitted by  
AECOM  
300 Lakeside Dr., Suite 400  
Oakland, CA 94612  
August 30, 2017

# Nevada Irrigation District Centennial Reservoir Project Geotechnical Engineering Report - Phase III – Final

**Subject: Centennial Reservoir Project  
Geotechnical Engineering Report  
Phase III - Final**

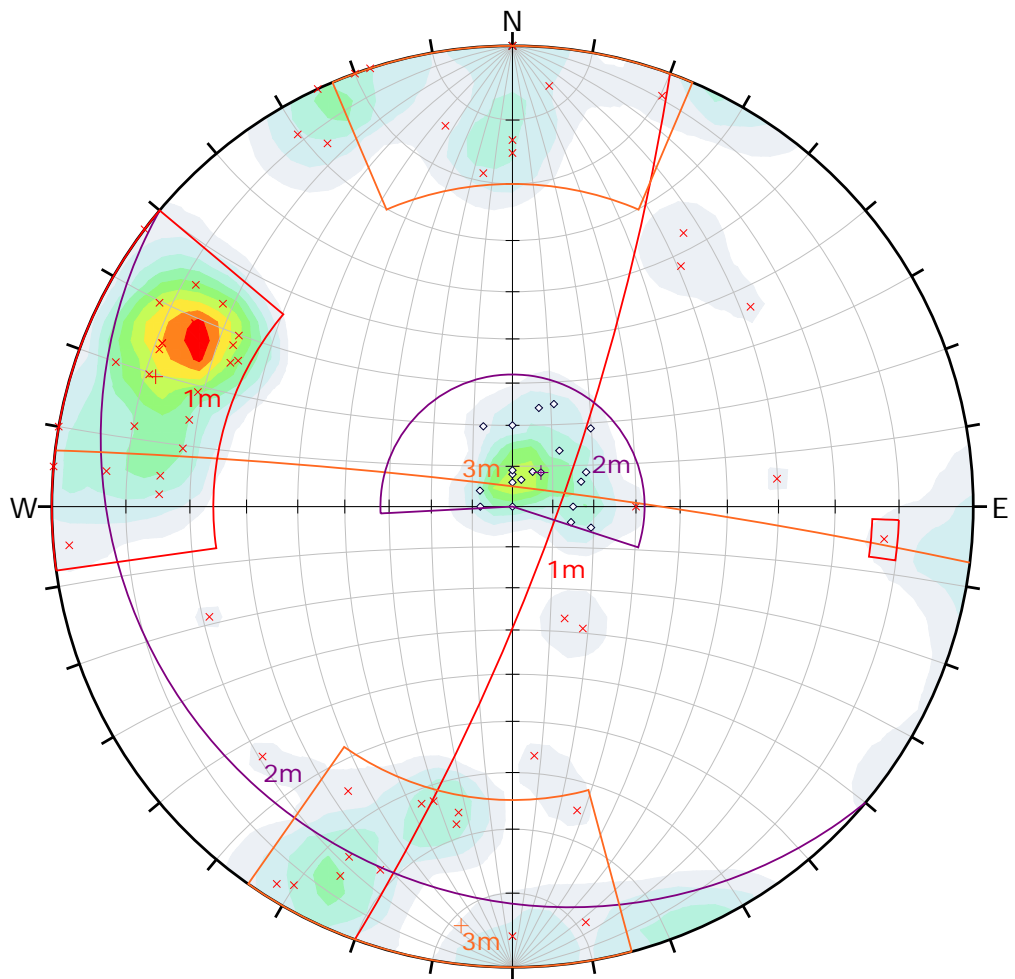
**Figure 4-3a**  
 Stereonet Plots of Surface Discontinuities - Dam Site Left Abutment

The mapped joint orientations were observed to be relatively persistent throughout the study area on both sides of the Bear River canyon. The joint surfaces observed in outcrops were generally slightly wavy, smooth to slightly rough, very narrow to tight, and with narrow bands of weathering along the joint surfaces. Geometry, roughness and weathering of the bedding and bedding-parallel joints were similar to the other joints.

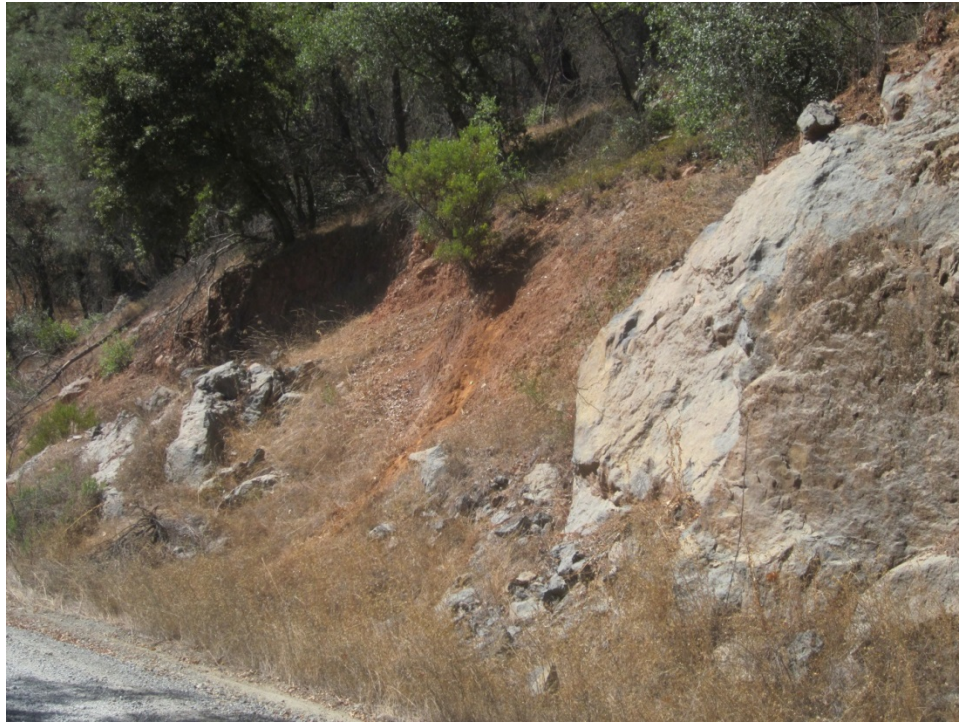
**Photograph 1. Typical section of residual soil observed within a road cut southwest of the CRP site**

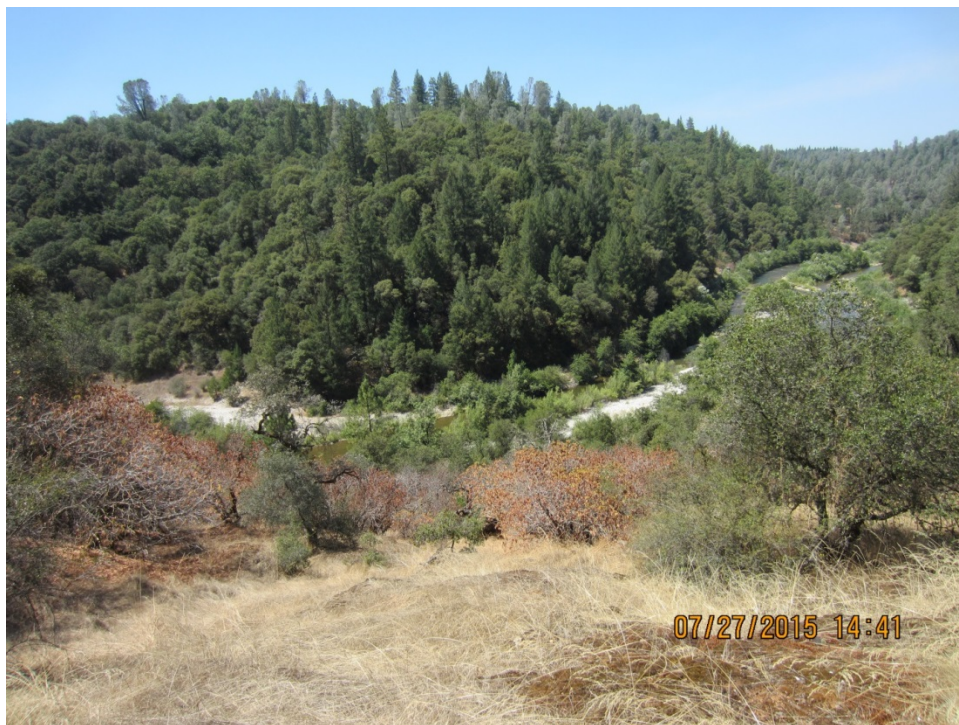
quartz from rock that is present upstream to the east in the Bear River drainage basin, but not in the project site. Though none was observed during the geologic mapping effort, the alluvial deposits may also contain chert based on the mapping performed by Tuminas (1983). Alluvium is present primarily as gravel bars within the river channel, which also contains extensive rock outcrops. The approximate limits of the alluvium in the site area are shown on Figure 4-1. Bedrock outcrops in the active river channel are also shown in Figure 4-1. Photographs 2 and 3 illustrate the Bear River alluvial deposits.

**Photograph 2. Northwest facing view of the Bear River from the southeast end of the site**  
 [Illustrates distribution of alluvial deposits within the active channel (Left: point bar; Right: mid-channel bar)].

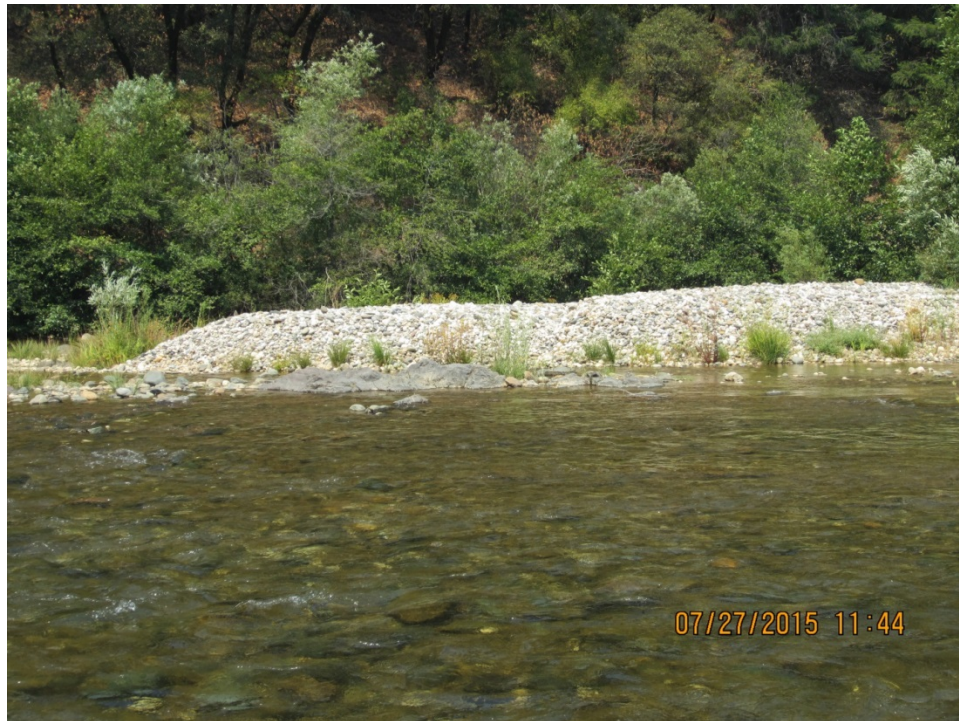
**Photograph 3. West facing view of outcropping bedrock and mid-channel bar deposits within the Bear River upstream of Axis 2**

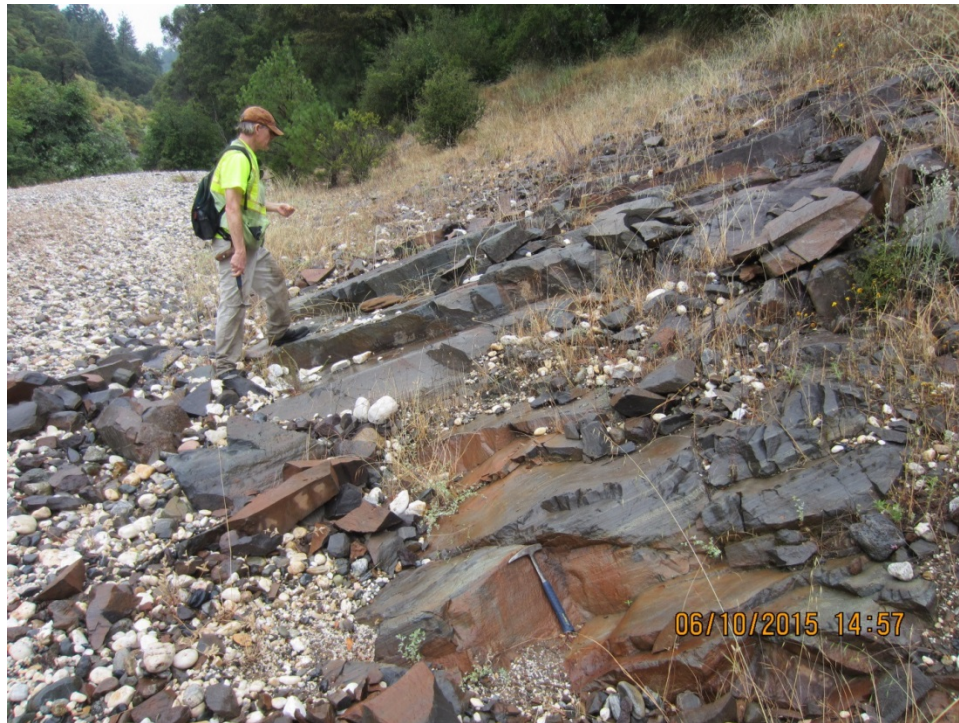
**Photograph 4. West facing view of bedding in outcropping bedrock (massive basalt) at the toe of slope along north bank of Bear River upstream of Axis 2**  
[Well rounded cobble and gravel sized point bar deposits are also visible (Left).]

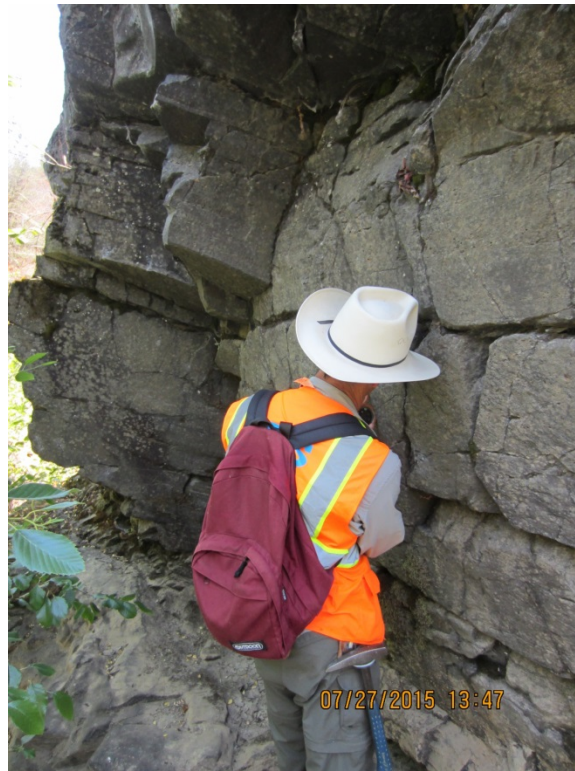
**Photograph 5. East facing view of typical discontinuities in outcropping bedrock (massive basalt) at the toe of slope along the south bank of Bear River**

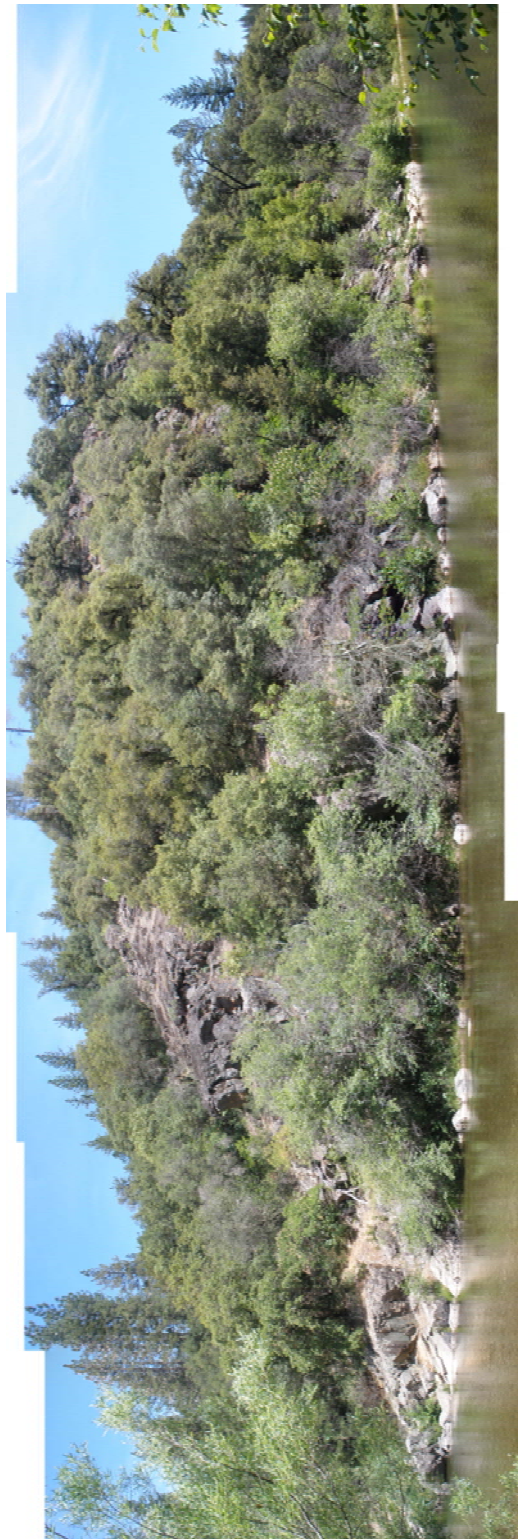
**Photograph 7. North facing view of the right abutment at Axis 2**  
[Illustrates steep (up to sub-vertical) slopes of outcropping bedrock (massive basalt).]

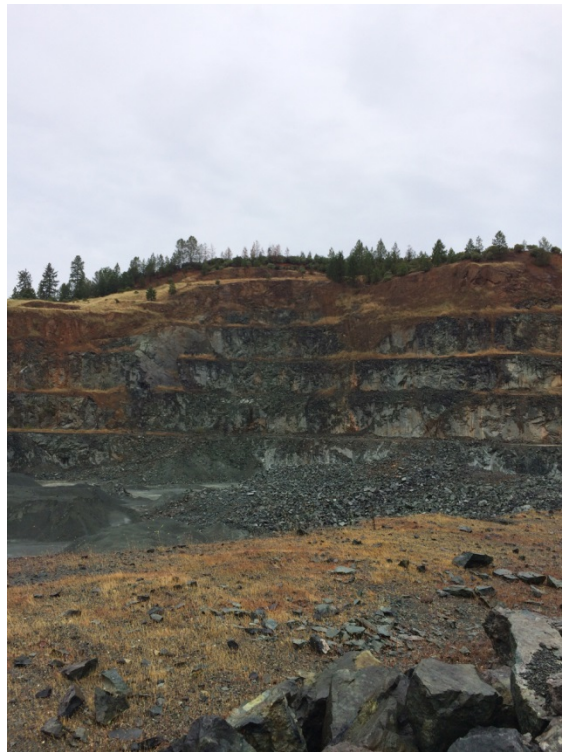
As stated in Section 3, no faults considered active by either the CGS or USGS are mapped within the CRP dam site area. During the geologic mapping for the current phase of study, two minor inactive faults or shear zones were observed within the nearby Bear River rock quarry. Based on observations of the sheared bedrock zones, these features are about 5 to 15 feet wide in outcrop, and are very steep to vertical. One of these features strikes N10°E-N20°E, oriented towards the north-south stretch of the Bear River within the CRP dam site area. The feature is also subparallel to a large dike exposed in the north quarry wall. This feature juxtaposes volcanoclastic breccia on both sides of the shear zone. The dike margins are bounded by the shear zone, with the most prominent deformation expressed along the western margin of the dike. Deformation is characterized by a zone of anastomosing shear-fabric, grain size reduction of the volcanoclastic breccia matrix, calcite recrystallization and apparent hydrothermal alteration. The shear zone appears to be continuous up-section in the quarry walls and across upper cut benches, although careful examination of the quarry walls along projection of the shear zone to the south and southwest revealed no evidence for the continuation of this feature. The second shear zone is oriented N55°E. These features appear to coincide with a regional discontinuity fabric that follows local reaches of the Bear River. Slickensides present along shear surfaces indicate a strike slip sense of past movement. Photographs 8 and 9 illustrate the minor inactive fault or shear zone features observed in the quarry.

On the basis of (1) the lack of lateral continuity of shearing across the quarry, (2) the spatial association of deformation with dike emplacement, and (3) the absence of any geomorphic expression of faulting to the northeast, we conclude there is a very low likelihood that this shear zone represents an active surface-fault rupture hazard for the proposed Centennial Dam.

**Photograph 8. North facing view of quarry shear zone in Bear River Quarry**  
[Orientation between N10°E and N12°W (arrow points to shear zone).]

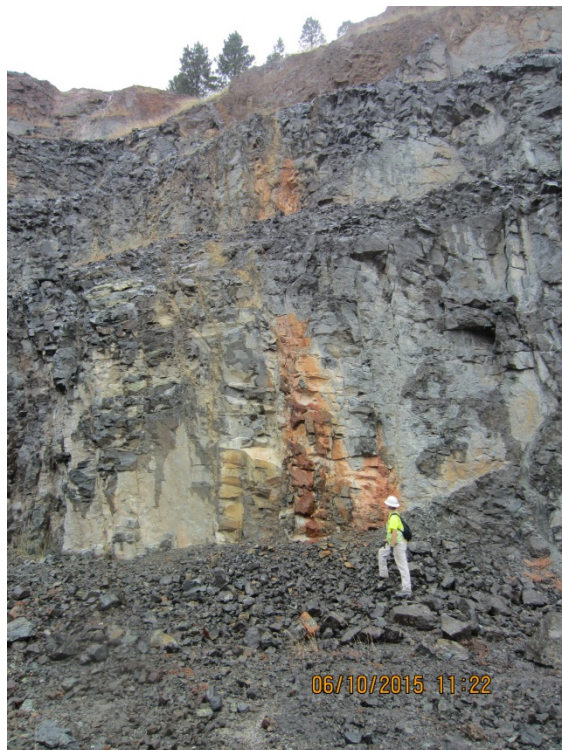
**Photograph 9. North facing close-up of quarry shear zone**
