Submitted by  
AECOM  
300 Lakeside Dr., Suite 400  
Oakland, CA 94612  
August 30, 2017

# Nevada Irrigation District Centennial Reservoir Project Geotechnical Engineering Report - Phase III – Final

**Subject: Centennial Reservoir Project  
Geotechnical Engineering Report  
Phase III - Final**

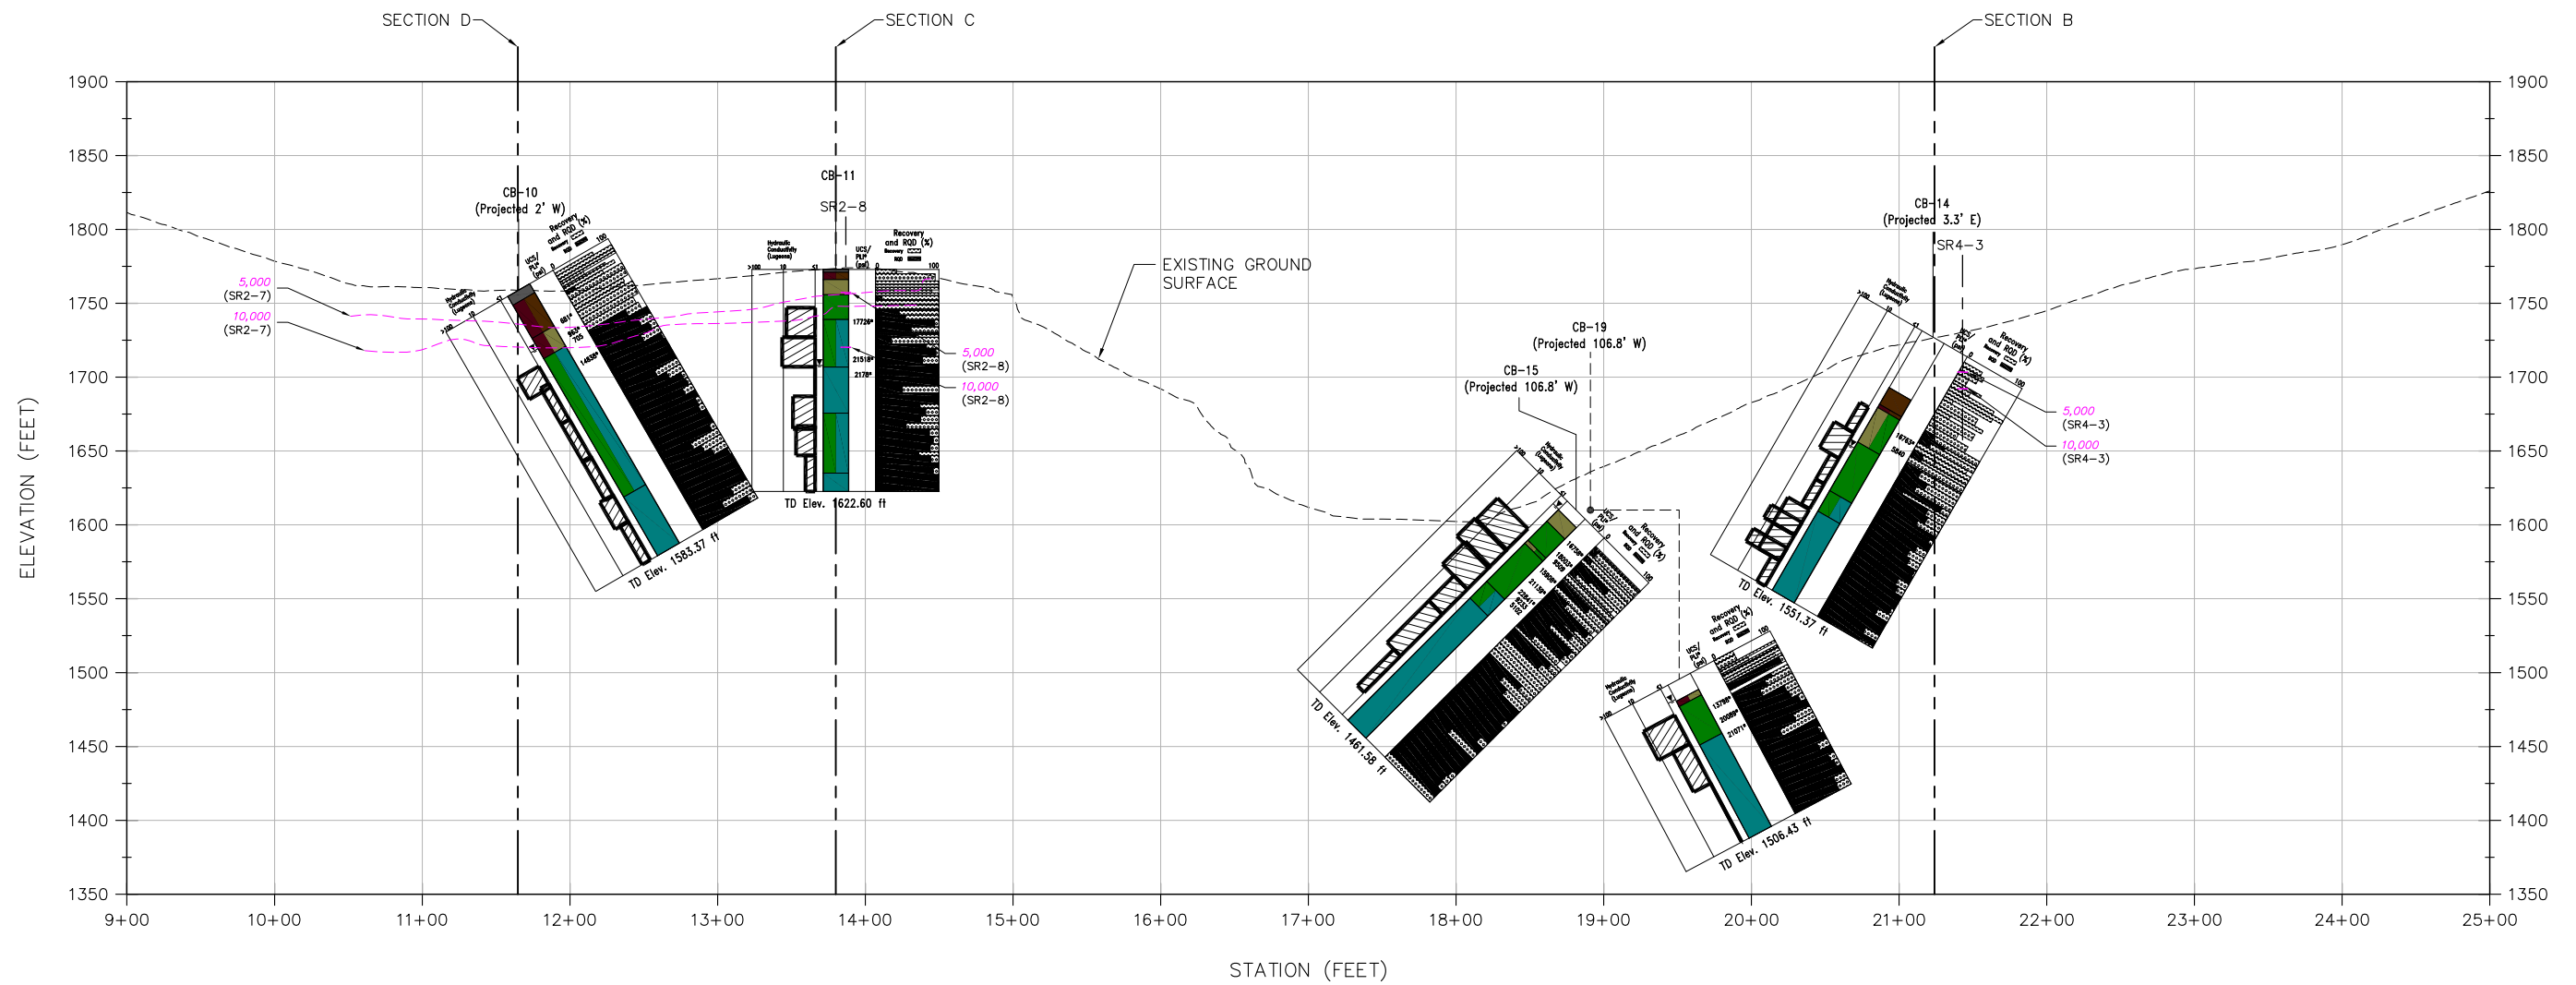
<b>AECOM</b>	60503855	Geotechnical Profile Upstream of Axis 2	FIGURE <b>6-2</b>
	NEVADA IRRIGATION DISTRICT CENTENNIAL RESERVOIR PROJECT

This section describes the foundation conditions at Axis 2 based on data collected from the core borings, seismic velocity surveys, rock strength testing, and discontinuity evaluation. Figure 6-1 shows a geotechnical profile along dam Axis 2. A parallel geotechnical profile located about 270 feet upstream of Axis 2 is shown on Figure 6-2. Three geotechnical sections transverse to the dam axis are shown on Figure 6-3.

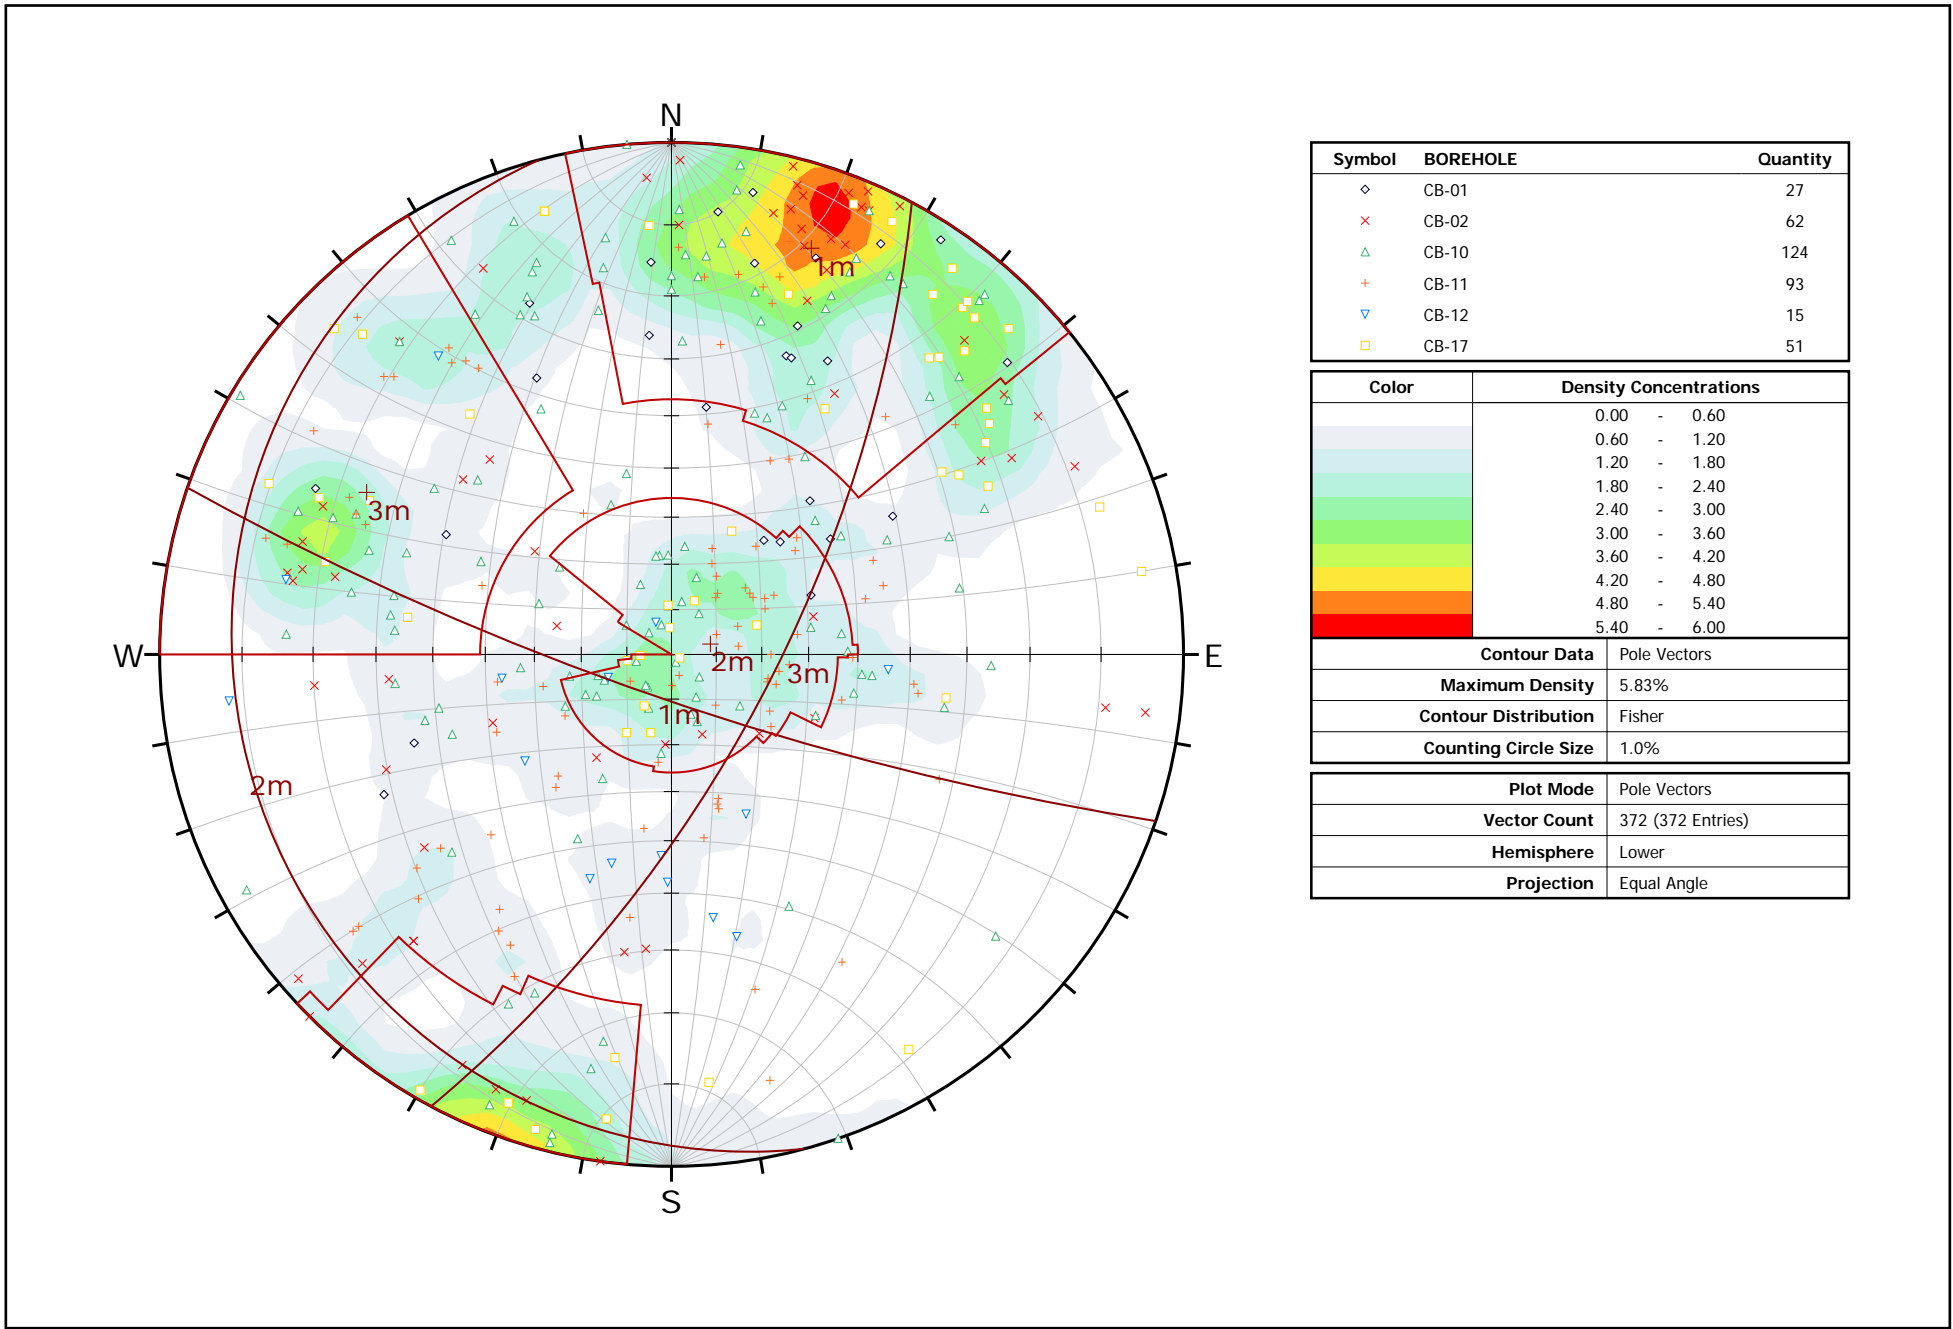
**FIGURE 6-4a**  
 Stereonet Plots of Borehole Discontinuities - Left Abutment Axis 2

Downhole televiewer logging was performed in ten of the twelve Phase III core borings. The logging obtained a total of 782 discontinuity measurements with depth, which are summarized in Appendix F. Prior to analysis, the televiewer logs were compared to the core boring logs to both verify identification and classification of discontinuities measured by the televiewer and to evaluate zones of highly weathered and/or fractured/sheared core and zones of poor recovery. The reviewed discontinuities were initially classified as significant (Class 1) to minor (Class 3). The classification process as well as the televiewer logging procedures are described in Appendix F. The discontinuities were combined with those measured in Phase II boreholes CB-1, CB-2, CB-3 and CB-4 for a total of 1116 features associated with Axis 2 borings. Lower hemisphere equal angle stereonet pole plots were prepared for discontinuity datasets compiled from boreholes located at each abutment and under the channel along Axis 2, to look for significant trends in the discontinuity data and define apparent spatial variations. Discontinuity sets were identified based on significant pole concentrations as illustrated in Figures 6-4a, 6-4b, and 6-4c and summarized in Table 6-4.

The discontinuity data shows two prevalent discontinuity sets and one less prominent set with some variance between the right and left abutments. The most consistent discontinuity set, gently dipping to the southeast to southwest, represents bedding features in volcanoclastic rock or flow fabric in basalt and basalt breccia. These bedding features are very prominent in both the right abutment (Figure 6-4b) and channel borings (sets labeled 1m) (Figure 6-4c) and are less prevalent in the left abutment borings (set 2m) (Figure 6-4a). The second prominent discontinuity set strikes roughly east-west and dips steeply south. This set is only present in the left abutment borings (set 1m) and represents joints and fractures within the rock. A third, less prominent joint set strikes N-NE and dips steeply to the E-SE. This set is present in both right and left abutments (sets 2m and 3m, respectively) but not in the channel borings.

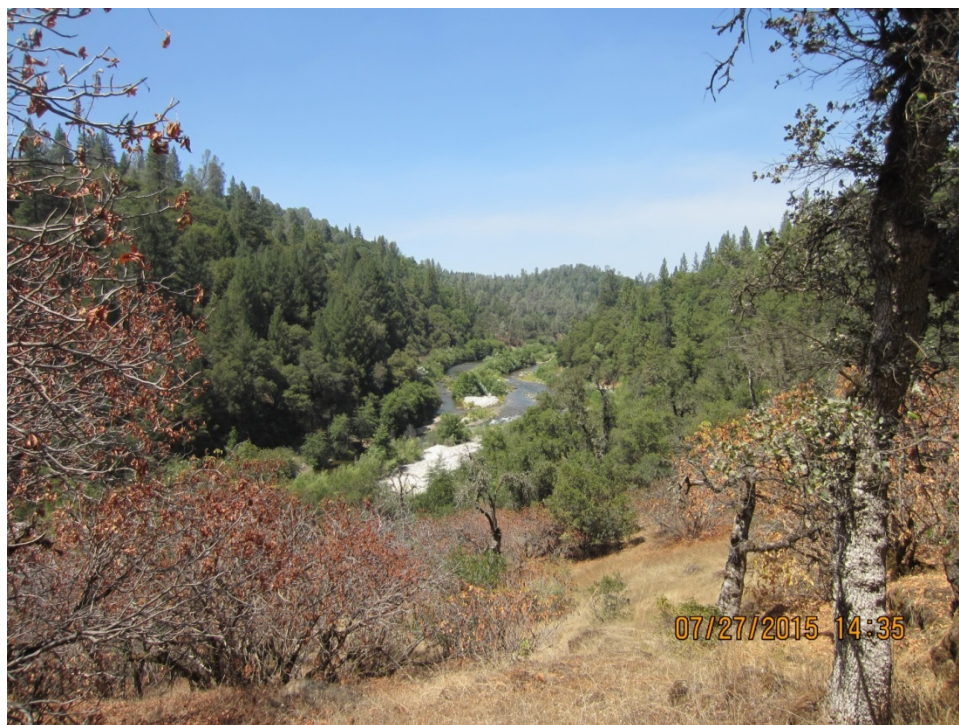
Surficial and structural geologic mapping performed for this investigation is shown on Figure 4-1. Bedrock mapping is depicted with two classes, based on continuity of outcrops, amount and interpreted depth of soil and degree of weathering. Areas mapped as bedrock outcrop (Class 1) are characterized by extensive, continuous rock outcrop at the surface that is generally moderately weathered to fresh, with occasional small, localized deposits of talus, soil and/or colluvium. Areas mapped as bedrock slope (Class 2) have fewer, isolated rock outcrops, typically with a greater degree of weathering. These areas may have locally thick deposits of residual soil where rock has weathered in place and may have some thin (generally less than several feet) deposits of colluvial soil. The margins of areas mapped as bedrock slopes (Class 2) are typically diffuse and gradational with adjacent bedrock outcrop or colluvial slopes. Also shown on Figure 4-1 are the locations of the observed rock outcrops where flow and clastic bedding was observed and recorded as well as the locations of observed apparent landslides. Photographs 4 and 5 illustrate the bedding and joint conditions of the bedrock. Photographs 6 and 7 illustrate the general morphology of the site.

**Photograph 6. North facing view of the Bear River channel**

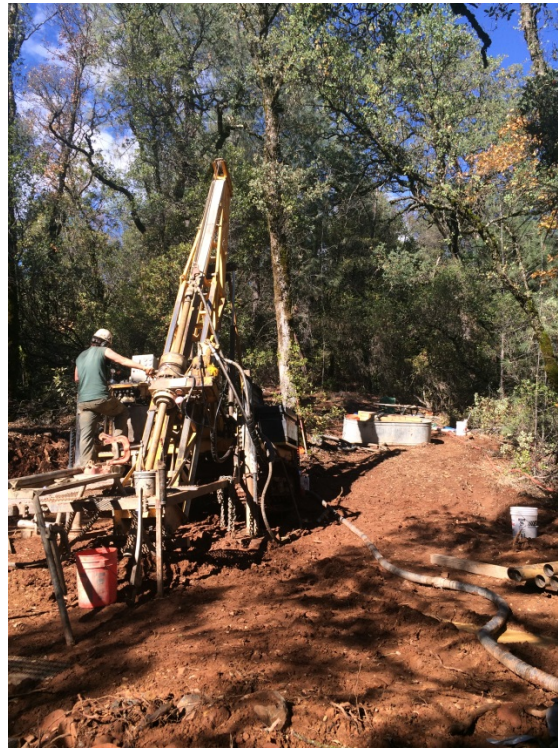
Water pressure (packer) testing was performed to assess the foundation hydraulic conductivities. The testing was performed in general accordance with USBR 7310, with tests in stages (generally 20 to 30 feet long) in the borings. The test results provide data for seepage analyses and to assess foundation grouting requirements. The water pressure test data is included in Appendix E. Photographs 10 and 11 show the typical core drilling operation.

**Photograph 10. Drilling Boring CB-3 (Axis 2, right abutment)**

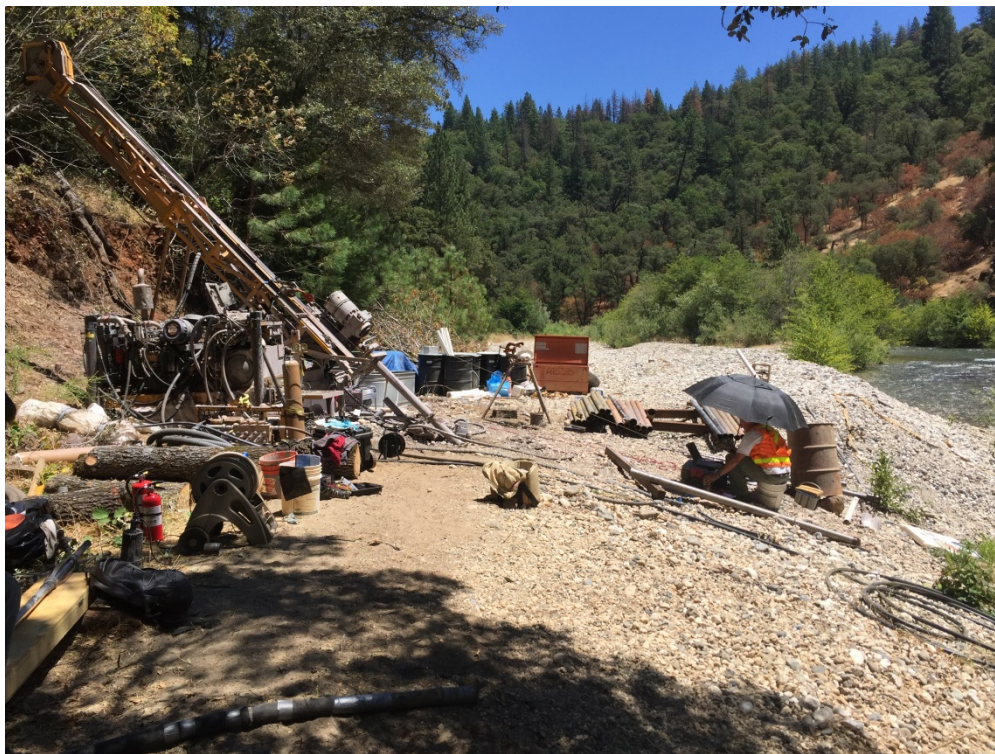
**Photograph 11. Drill rig with televiewer logging at Boring CB-15**
